BUREAU OF SHIPS GROUP
TECHNICAL INSPECTION REPORT

⑥ OPERATION CROSSROADS.
U.S.S. HUGHES (DD410)

TEST ABLE [U].

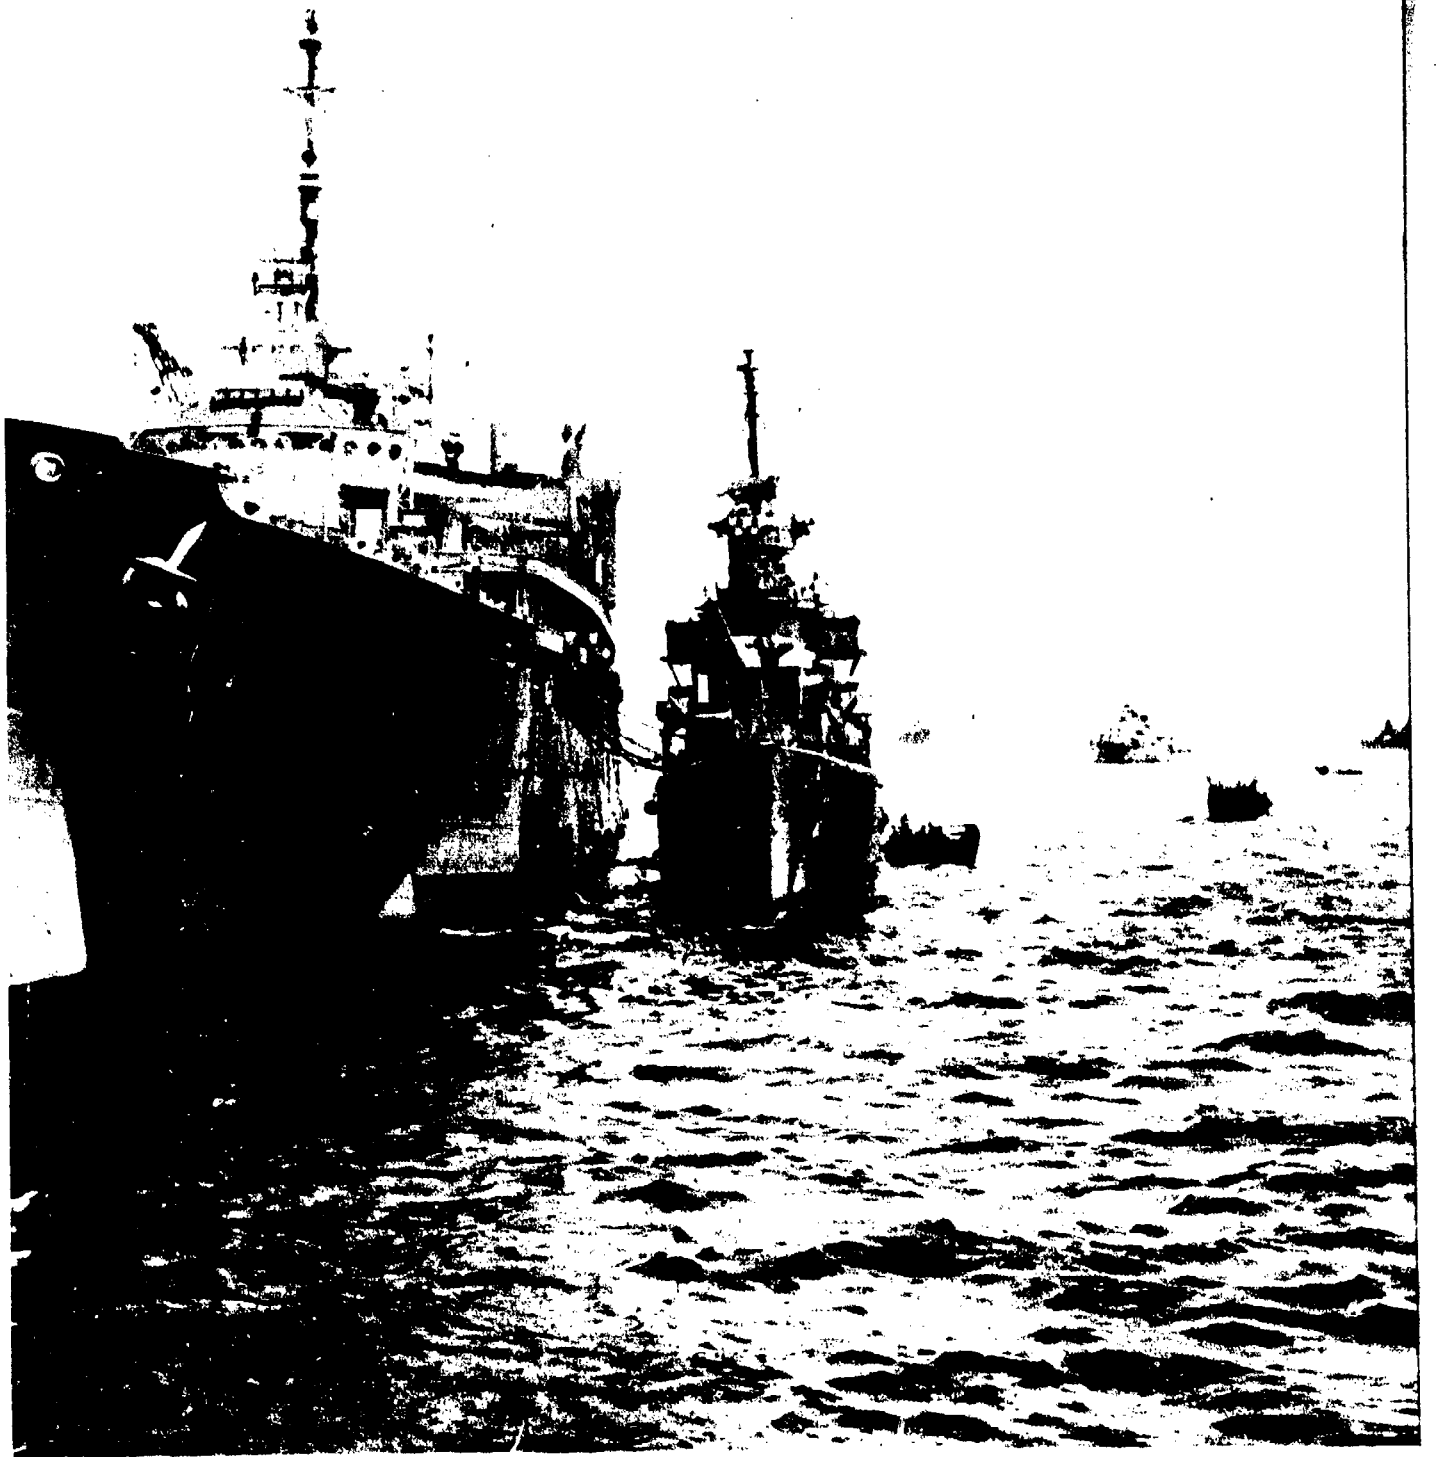
AA-CR-227-49-85. Bow after Test A.

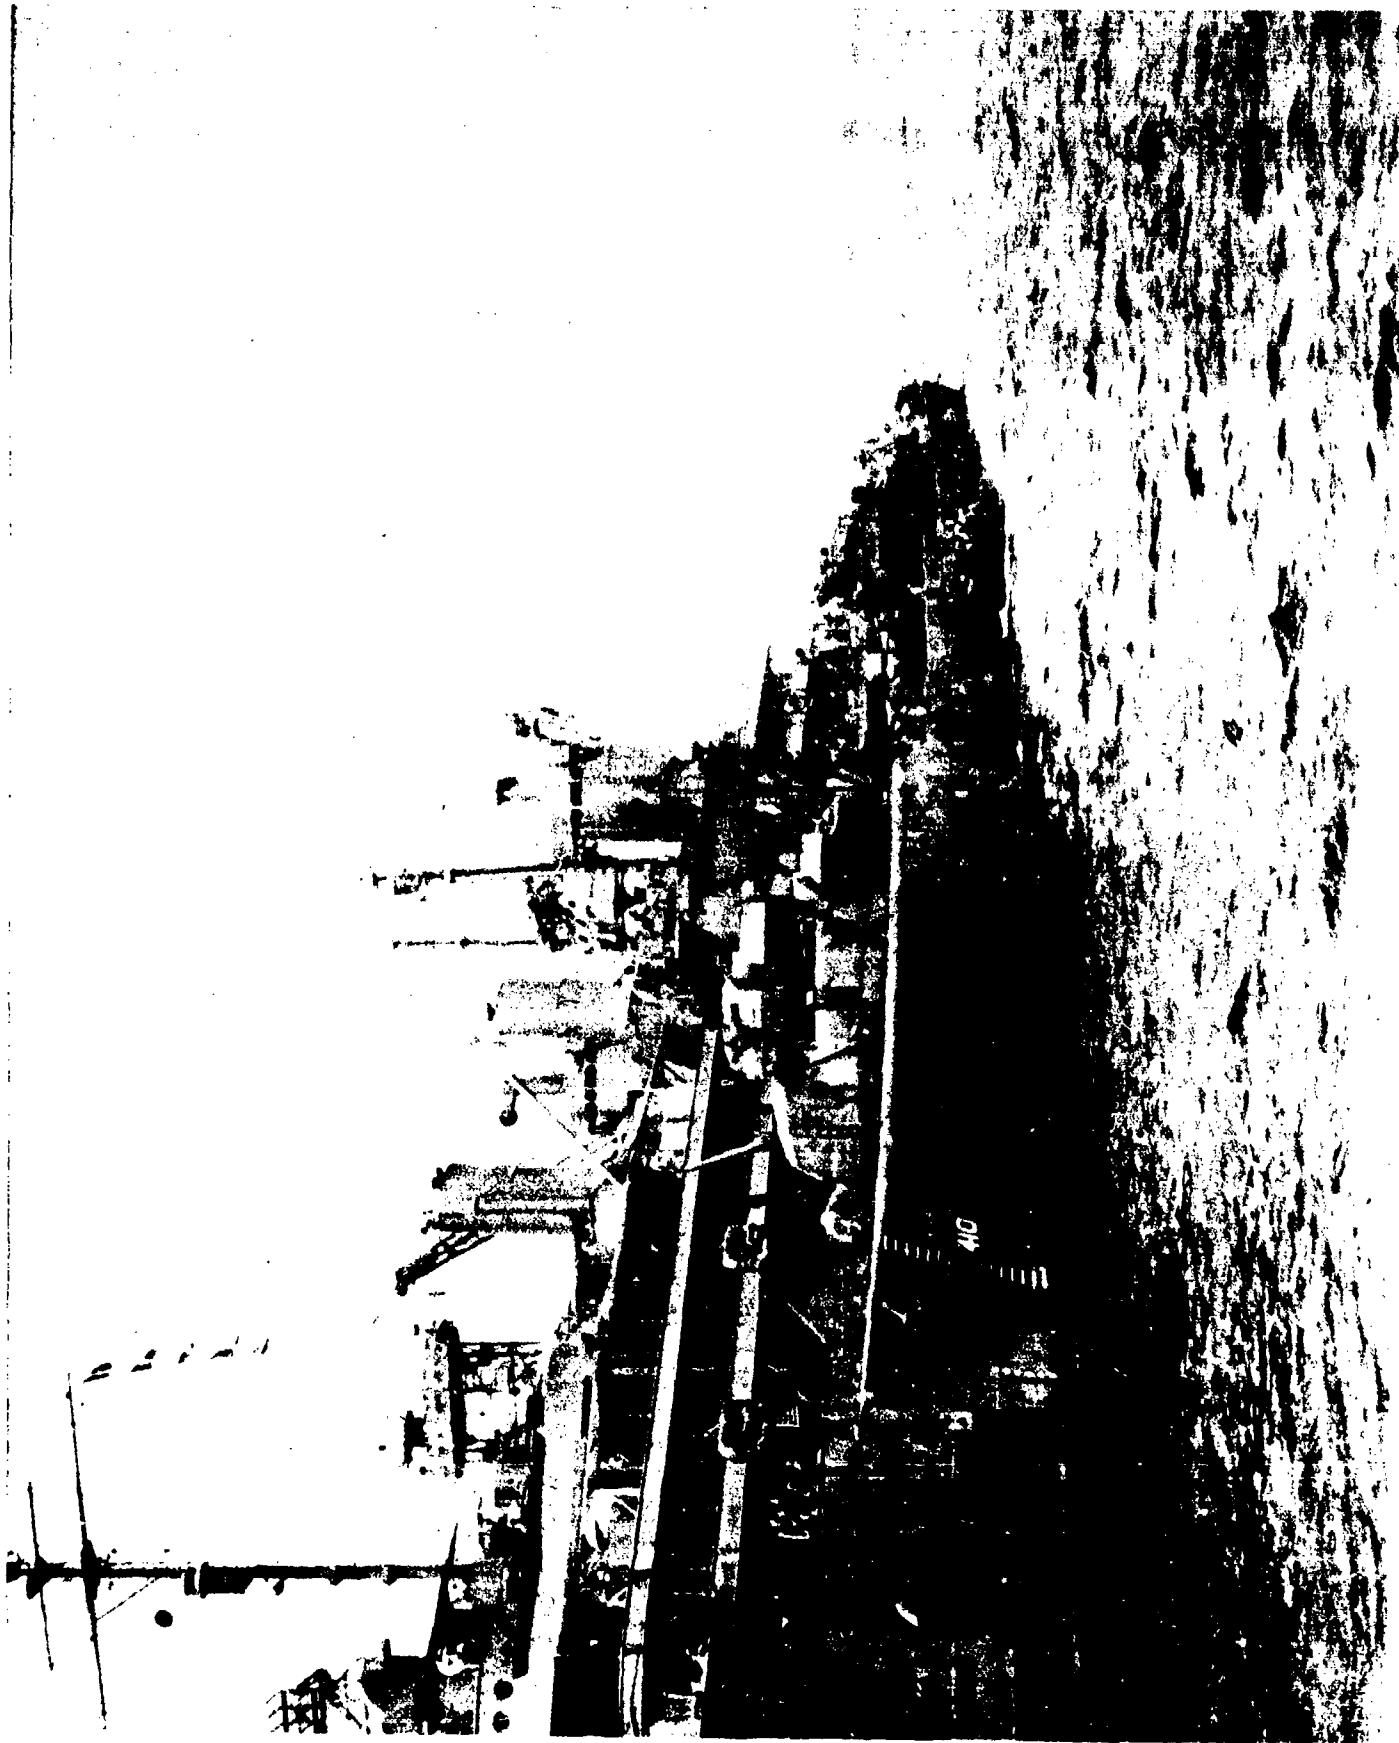
AA-CR-227-49-84. Port bow after Test A.

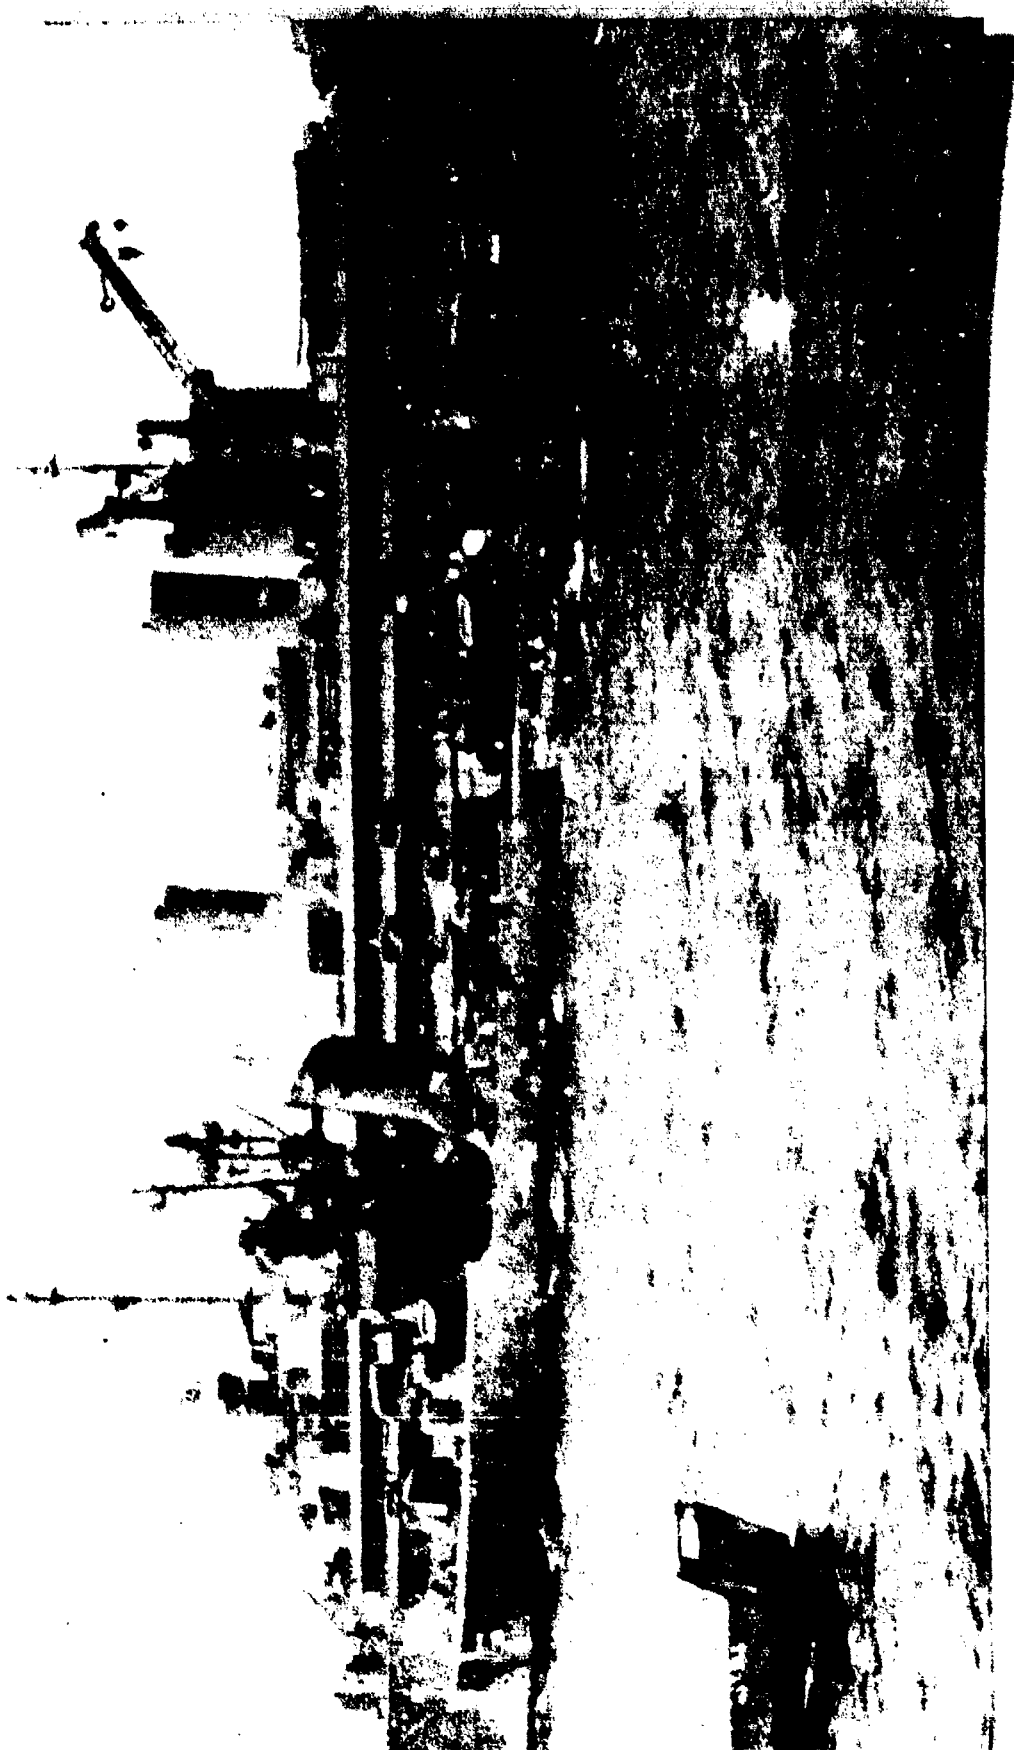
AA-CR-227-49-82. Port beam after Test A.

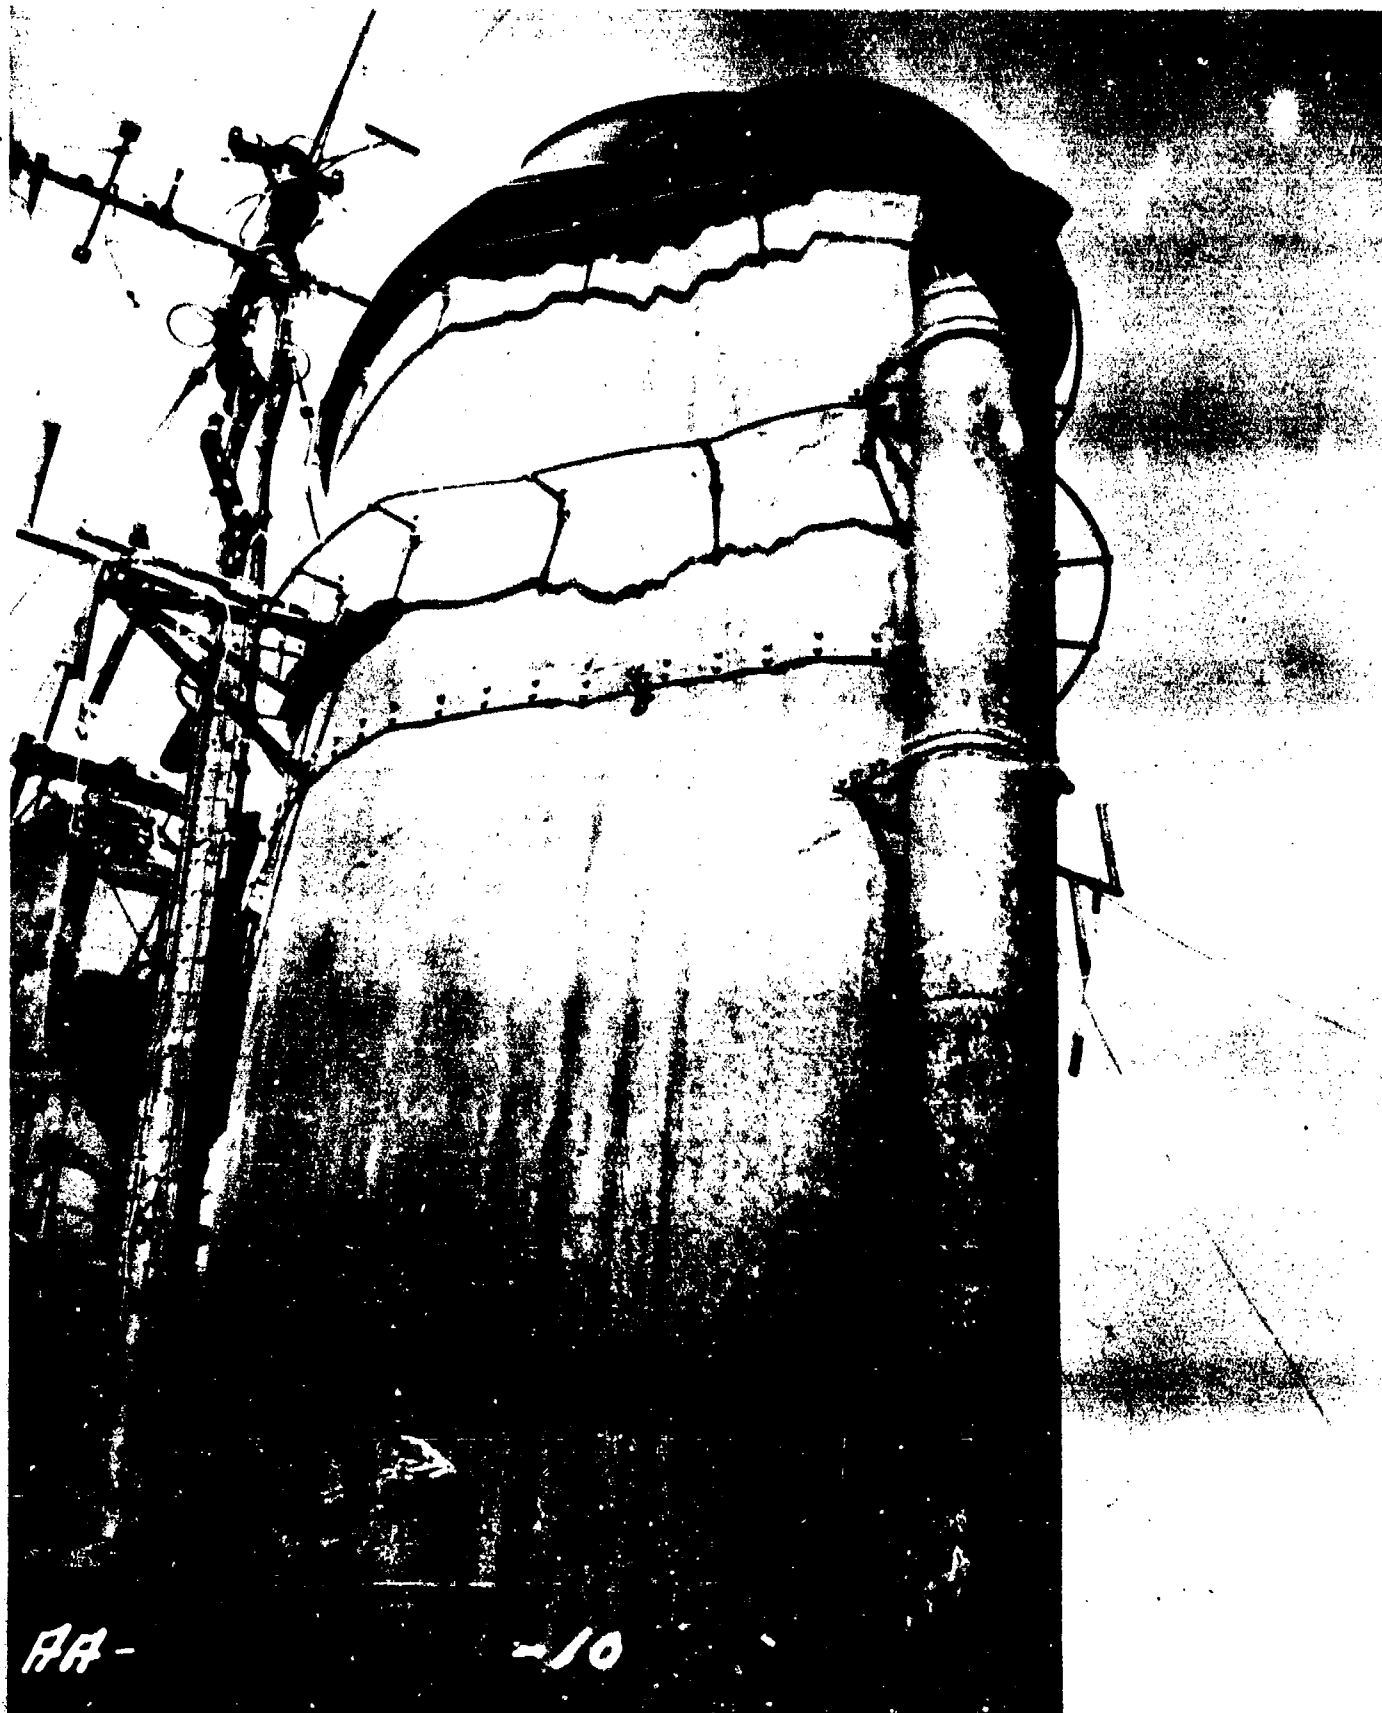
The stack is dished for about the top ten feet on the after port corner, (photo 1747 10; Page 67). The funnel cap is distorted in way of this damage and the top edge is pushed in. Compression wrinkles appear in the forward face of the stack (photo 1849-10; Page 66).

AA-CR-68-1747-10. Port after sector, of stack, looking forward and to starboard.

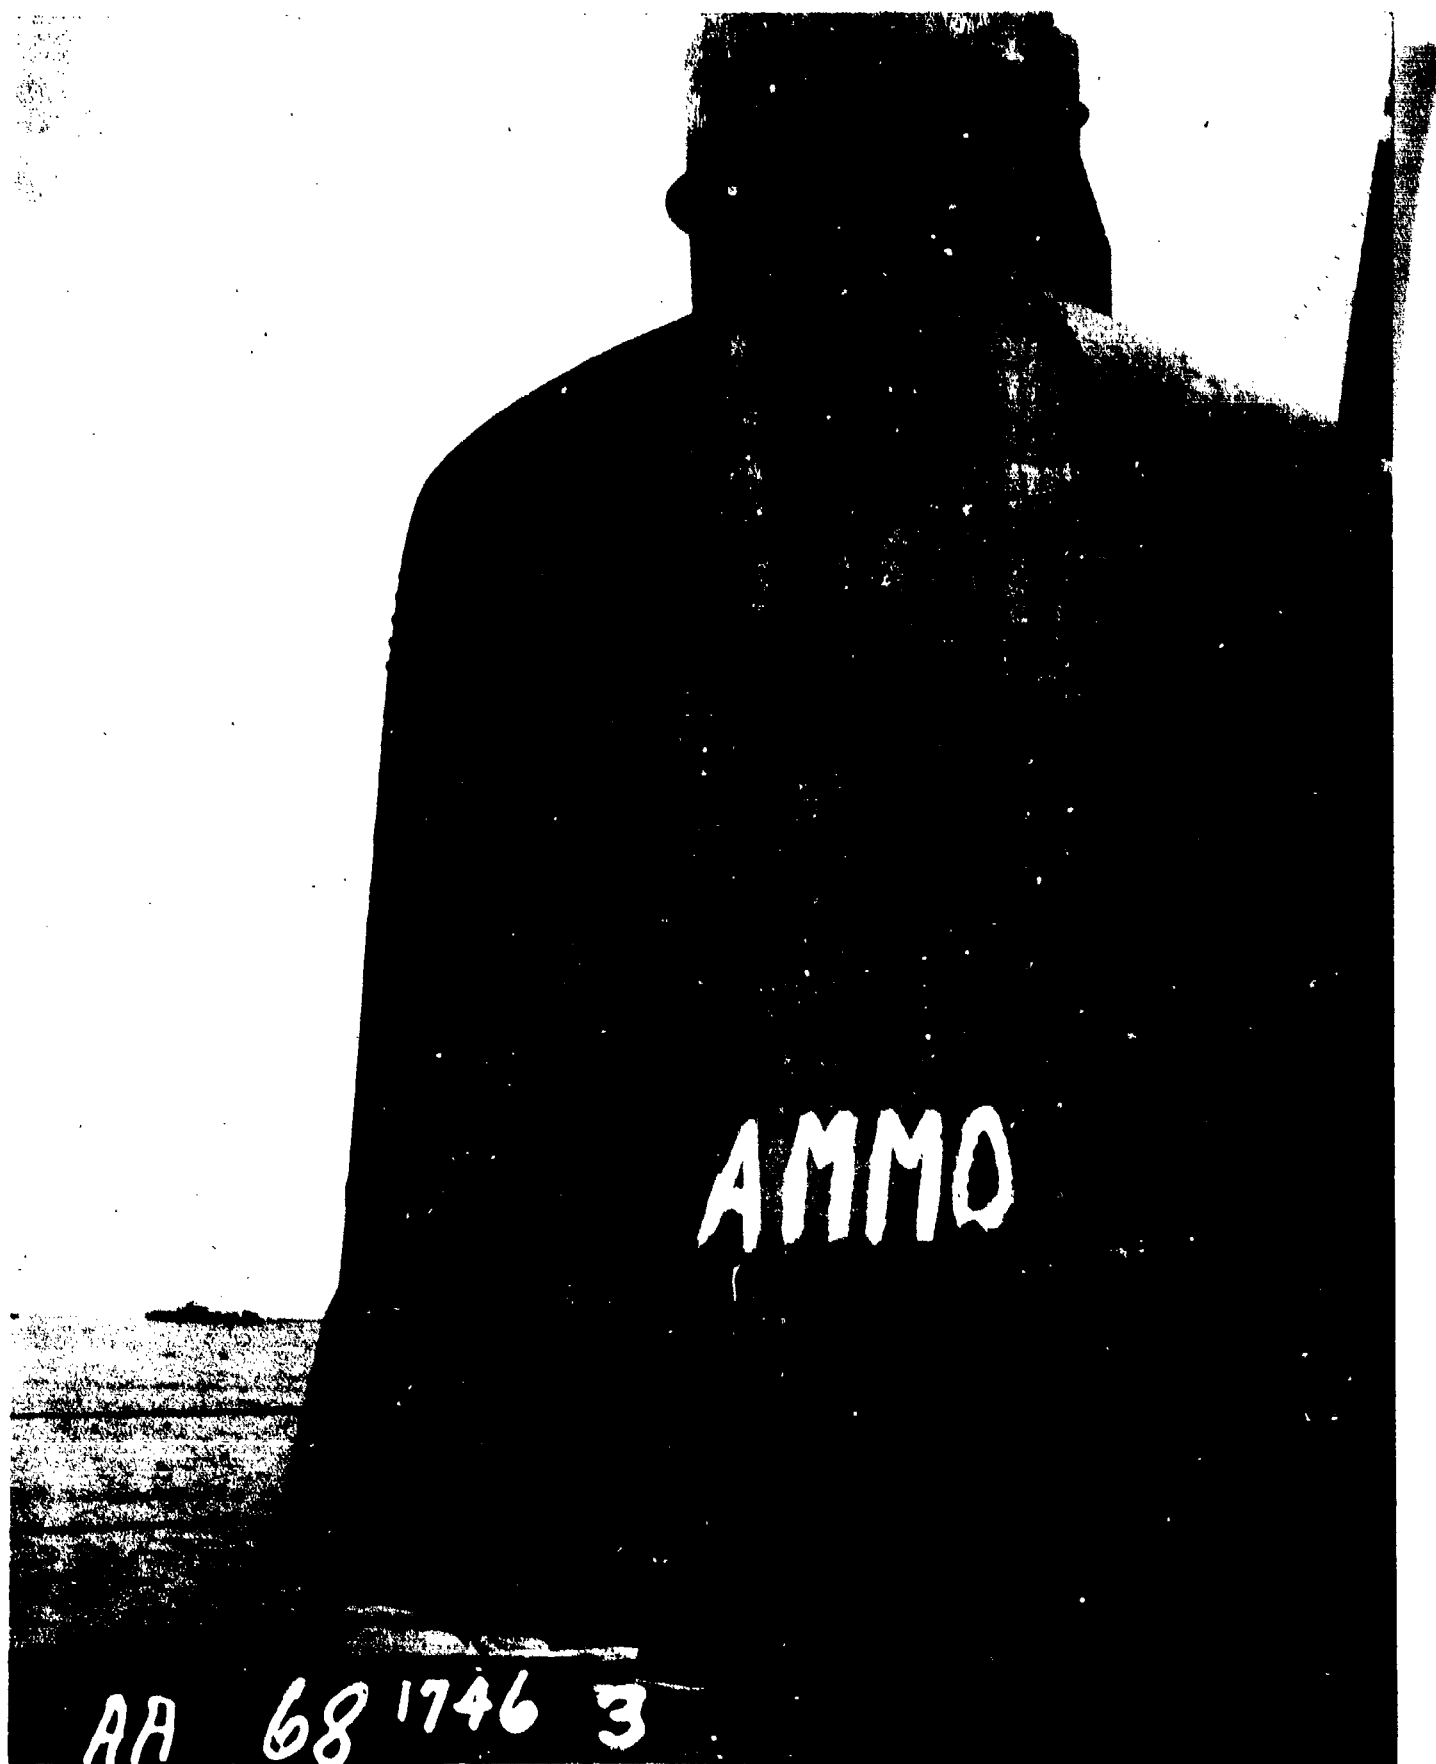
AA-CR-68-1746-3. No. 1 mount, dishing of rear plating.

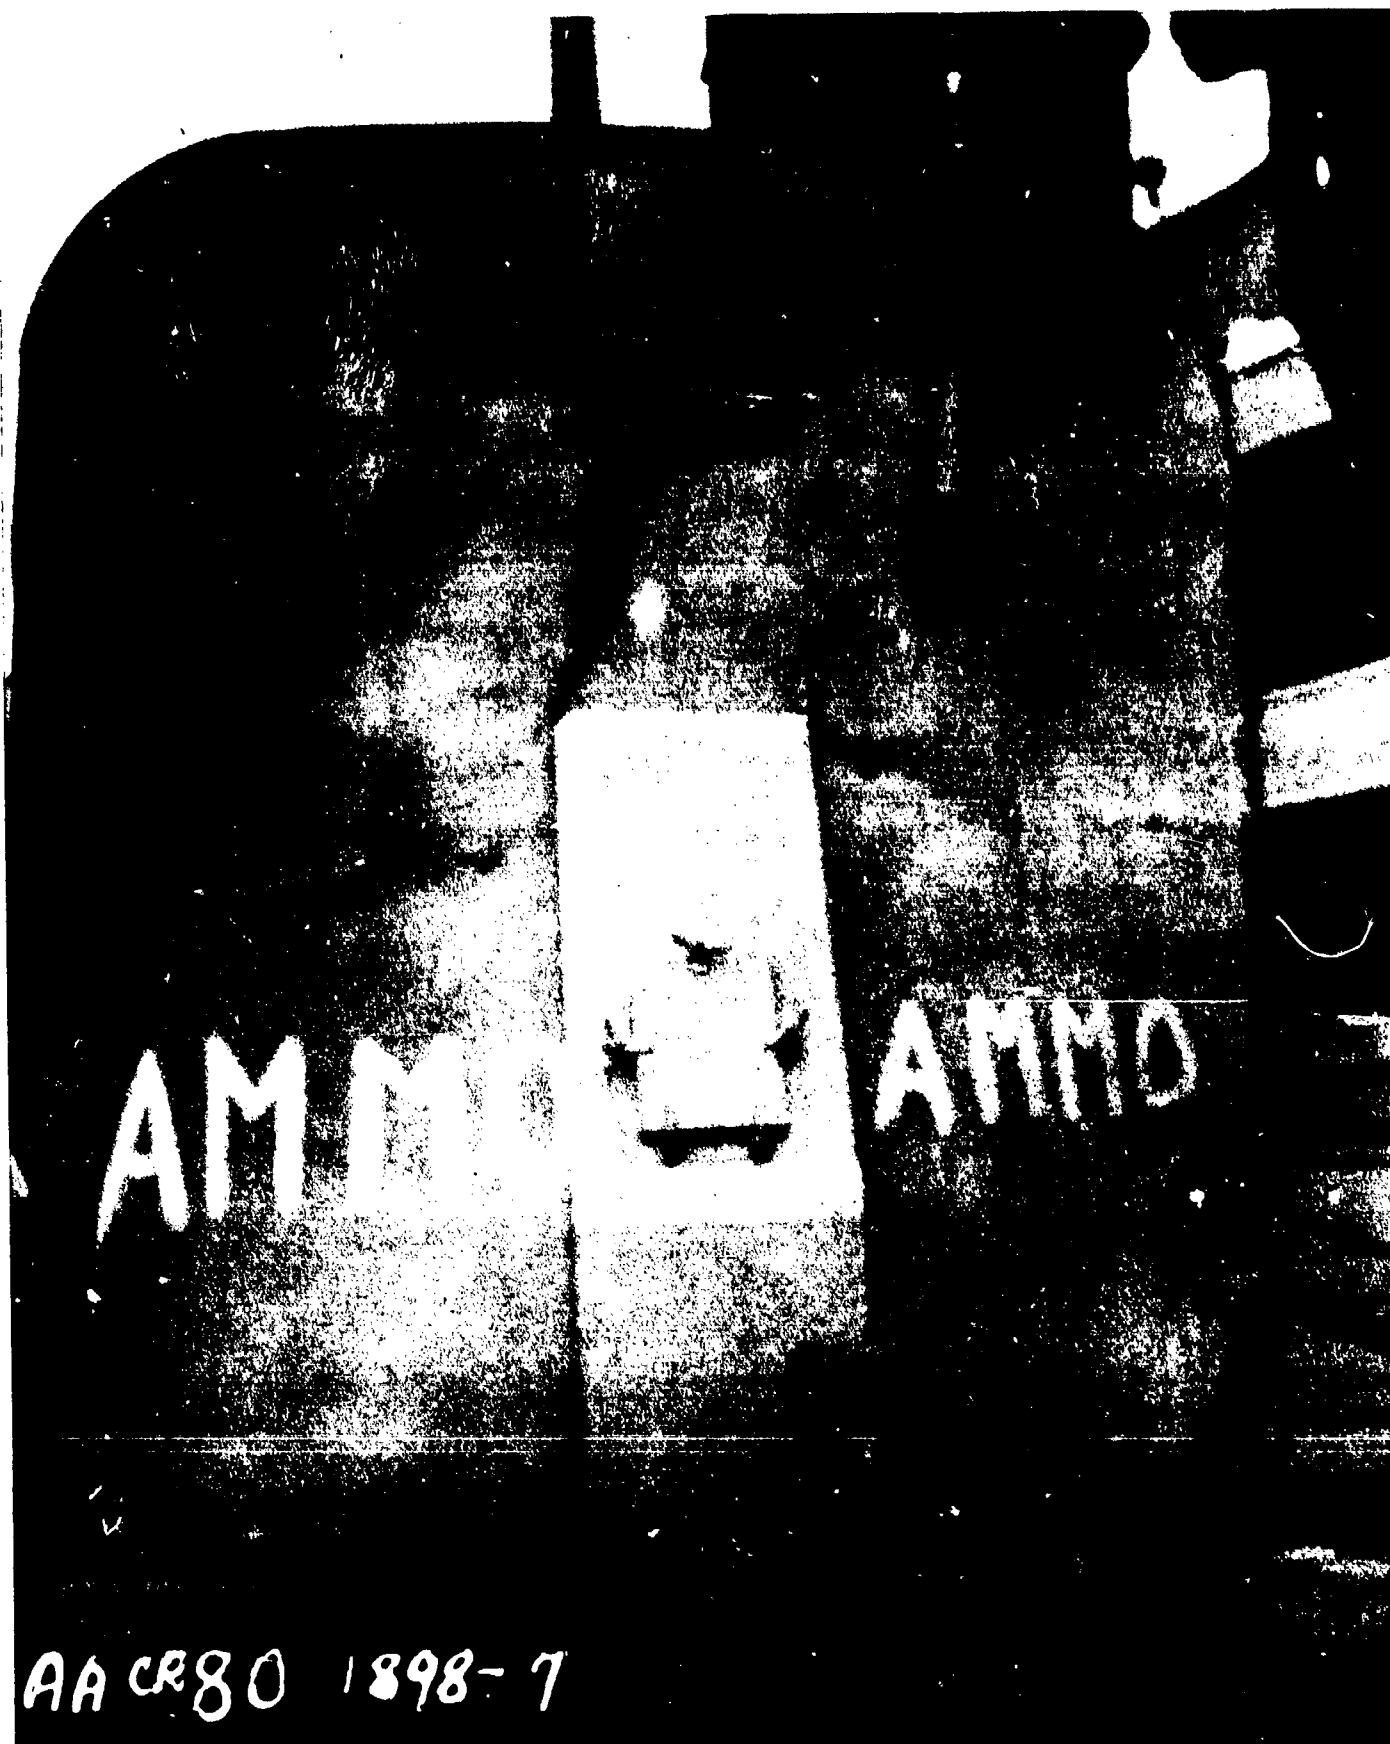
AA-CR-80-1898-7. Damage to back plating of No. 1 gun mount.

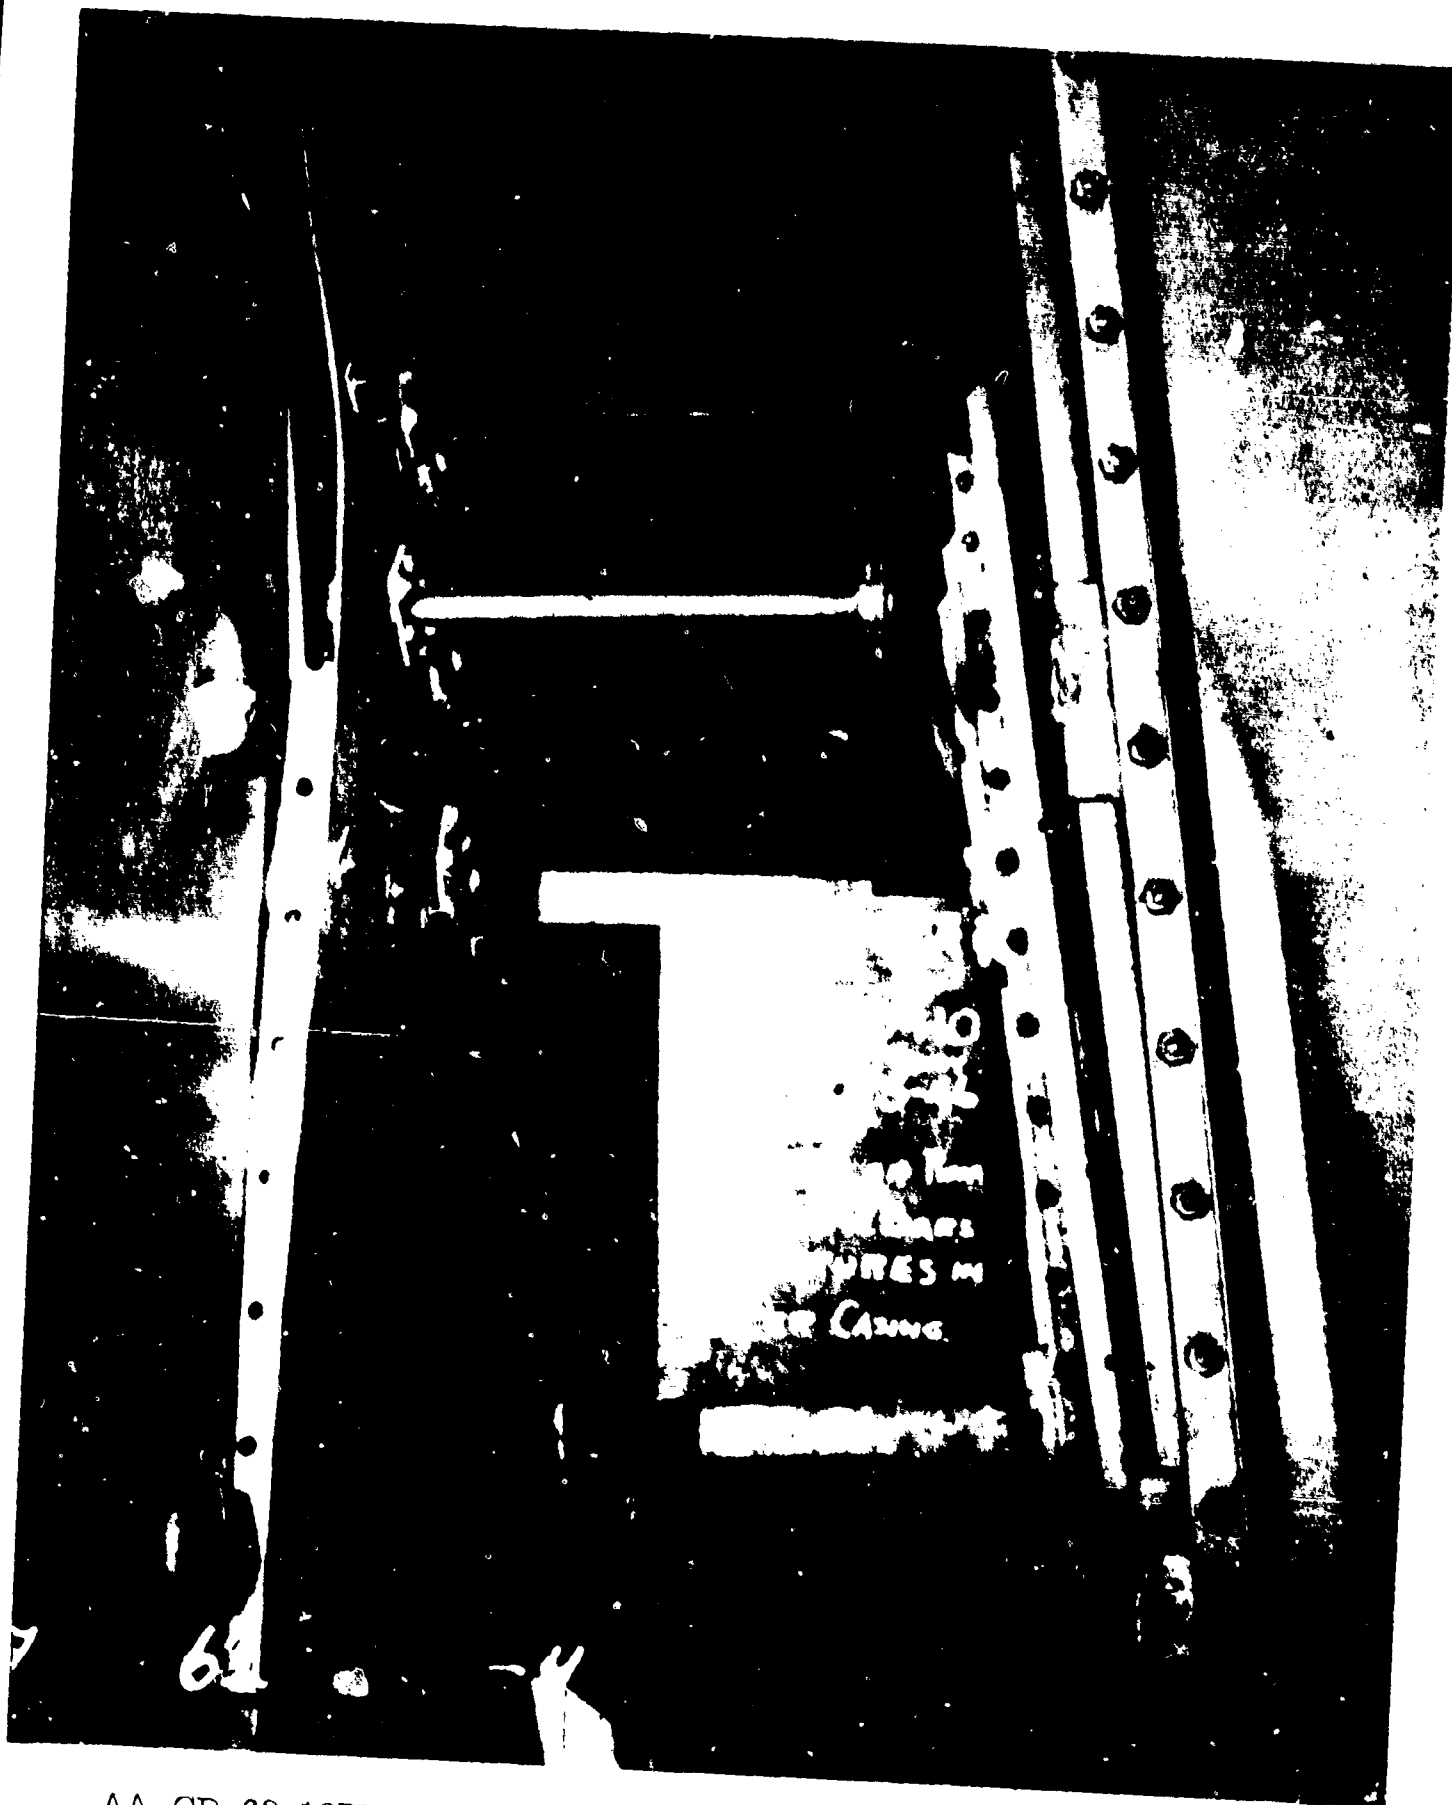
AA-CR-62-1875-4. No. 1 boiler near casing tie bars, and ruptures in outer casing.

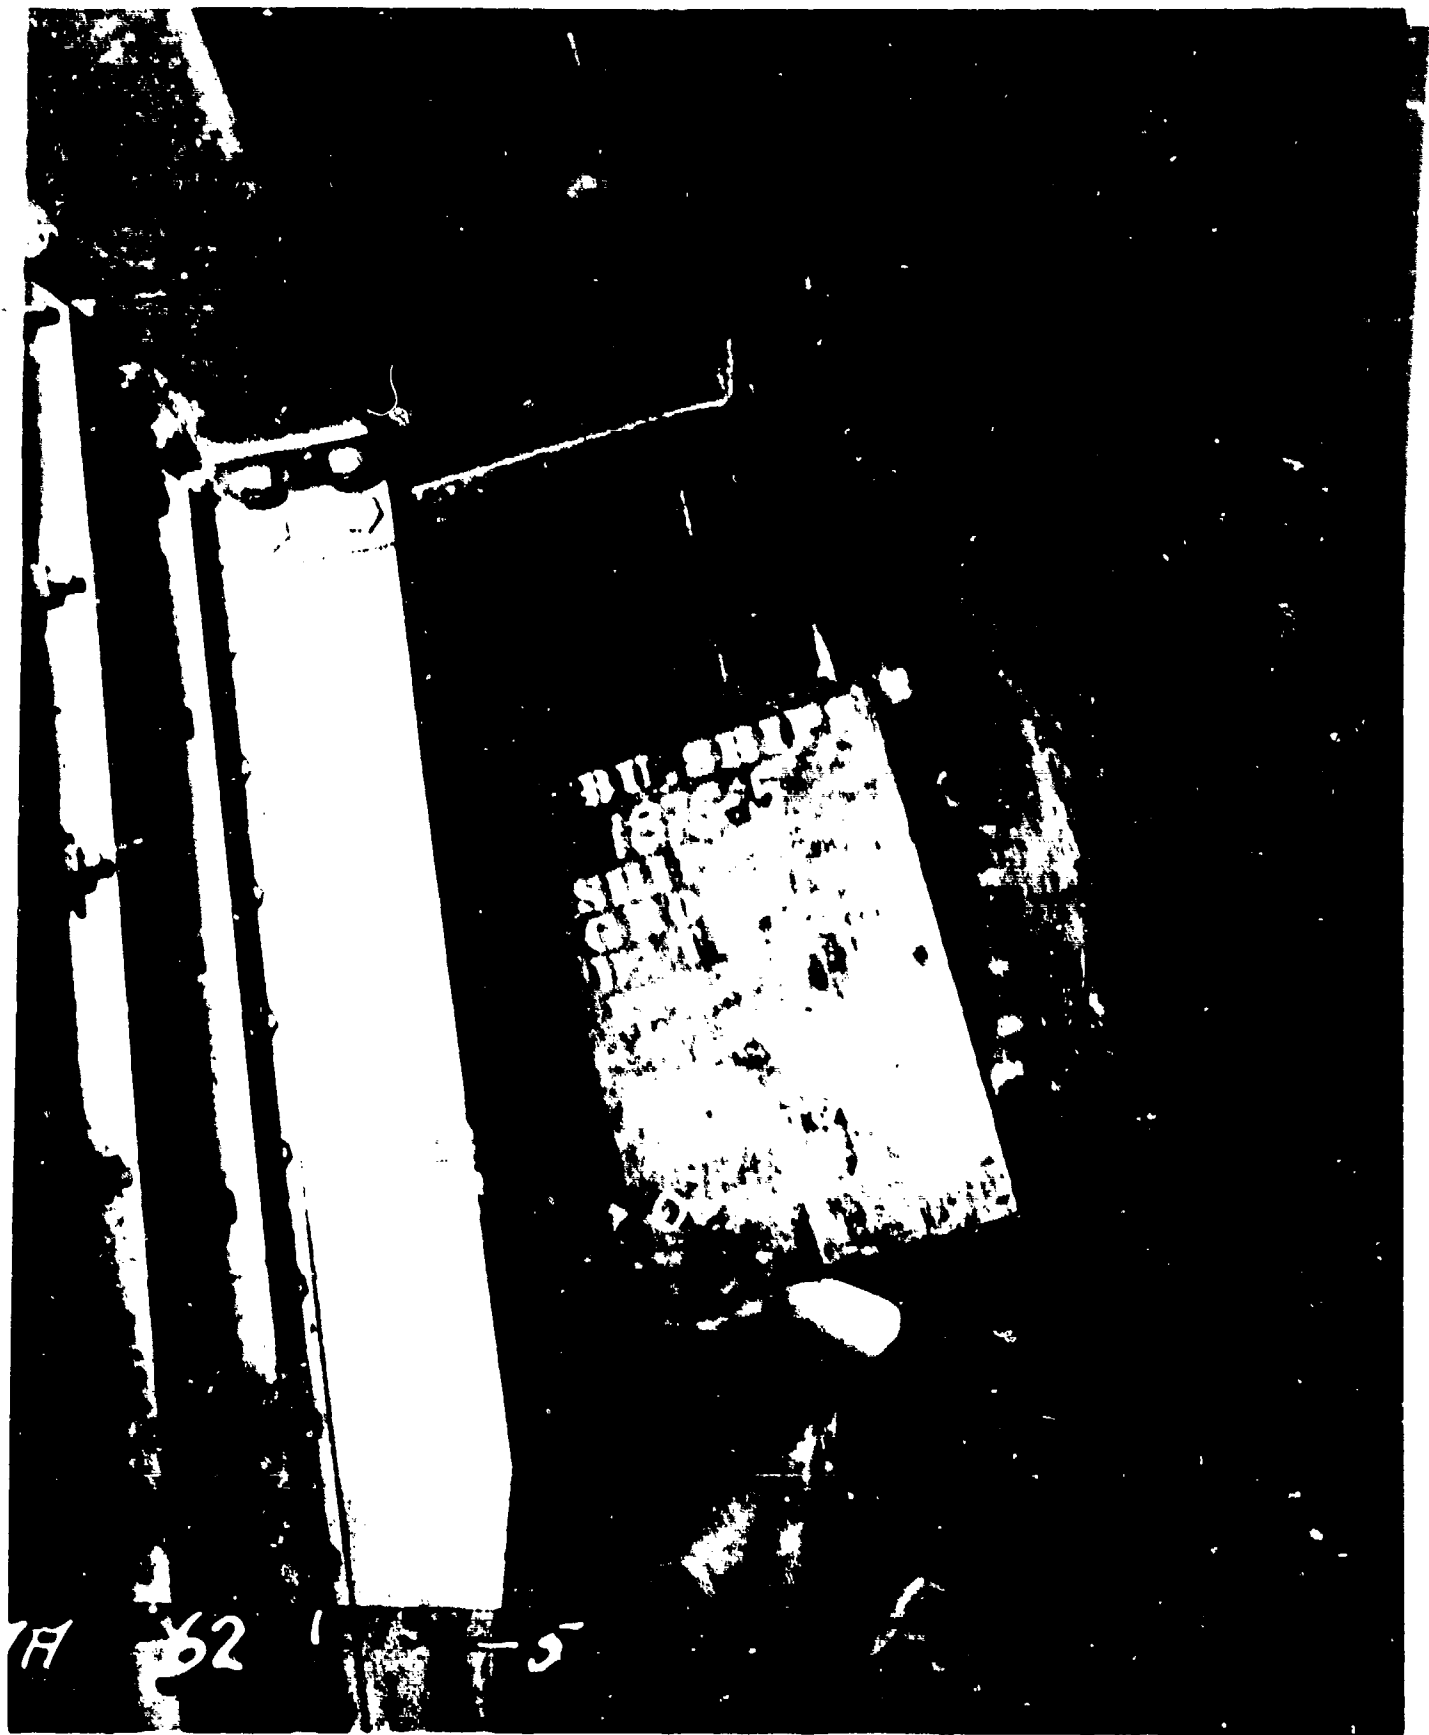
AA-CR-62-1875-5. No. 1 boiler rear casing tie bars, and ruptures in outer casing.
